Philips Medical Systems

FIELD CHANGE ORDER

Issued by: PMS DMC HamburgReference No.: FC074200007Released by: Karl-H. HamburgsignedDate: September 2, 2002

Transport wheel problems with generator cabinet 40E.

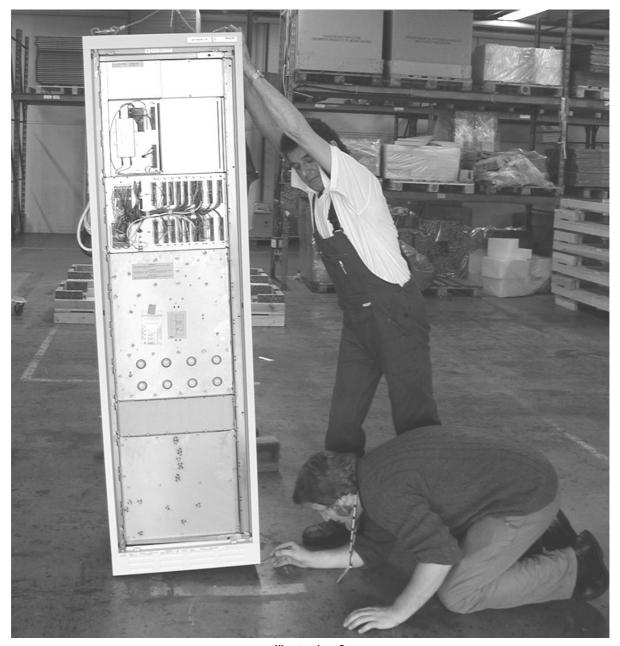
Illustration 3

In case of Optimus 30/50/65 RAD / RF / C generators DO NOT tilt more than 20°. Air bubbles can stick underneath of the HV metal screen inside the tank (illustration 3).

• The second person must check with the mirror provided in the standard tool kit whether all four transport wheels are secured with a retaining ring and washer on both sides of the wheel. (illustration 3).

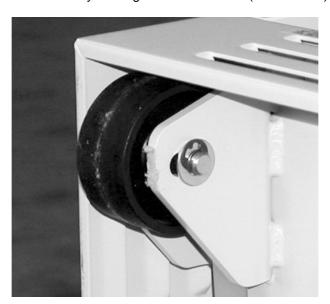
Illustration 5

1.) The retaining rings do not sit securely in the grooves of the axle (illustration 5).

• Disconnect all cables of the generator cabinet.

- Check the washers are still in place.
- Use suitable pliers to insert the retaining rings properly in their groves.
- Continue at step 'Re-attach the HV tank......', point 3 on next page.
- 2.) The retaining rings are missing completely (Illustration 7).
